## **FACTORS OF GULLY EXPANSION IN DAURA GULLY SITES IN DAURA LOCAL GOVERNMENT AREA OF KATSINA STATE, NORTH-WEST NIGERIA**

Inalegwu, E. O., & Okafor, U. P. (2025). Factors of gully expansion in Daura gully sites of Daura Local Government Area of Katsina State, North-West Nigeria. *International Journal of Economics, Environmental Development and Society*, 6(2), 340-355.

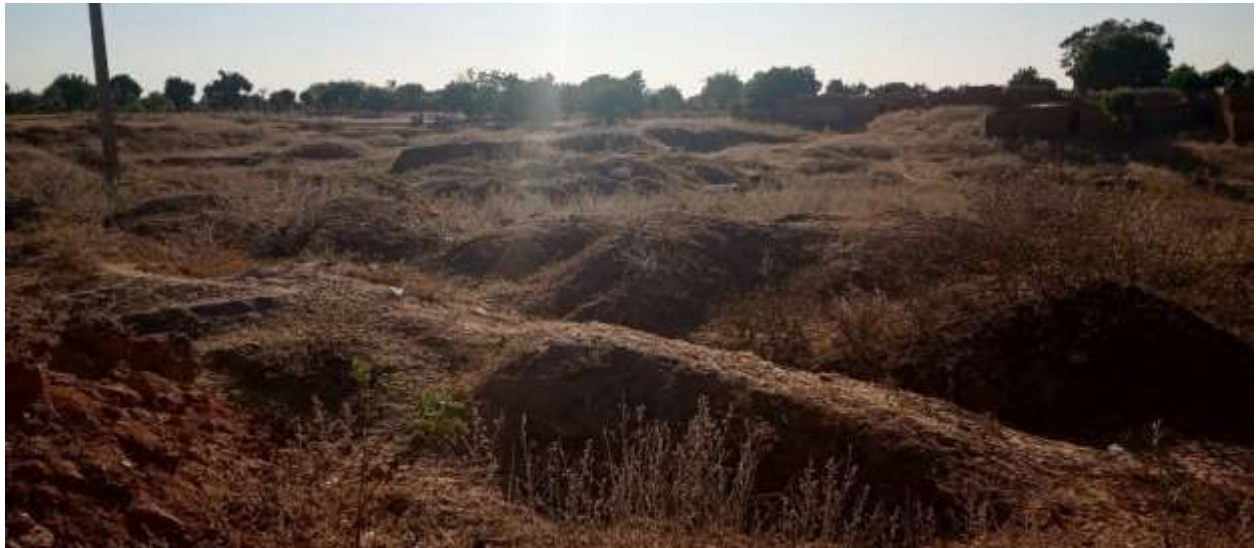
Figure 3: Gully site at Sadanmu Area of Daura LGA

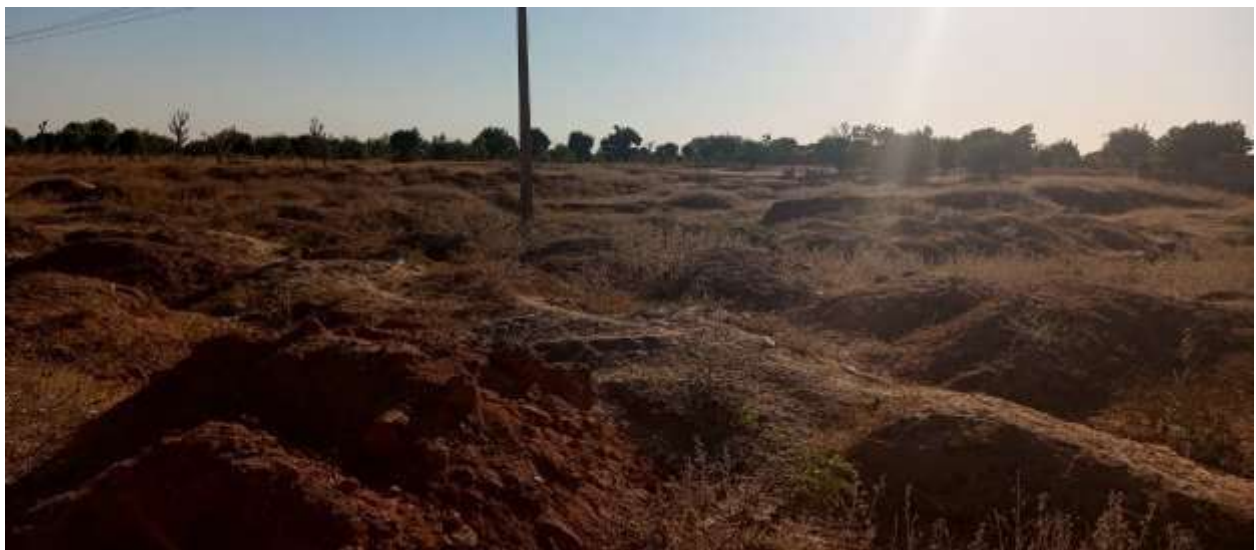
Figure 4: Gully site at Mazoji Area of Daura LGA
